**Flood Control Project Maintenance  
Levee Inspections**

**Maintenance Issue Types Only, Levee Inspection Report By Mile - Fall 2019**

**Sacramento Maintenance Yard Putah Creek**

Waterway	Bank	Unit Miles	Inspection Start/End	Inspector
Unit No. 01 Putah Creek or North Levee	Left	8.79	10/08/2019 10/08/2019	David Julian

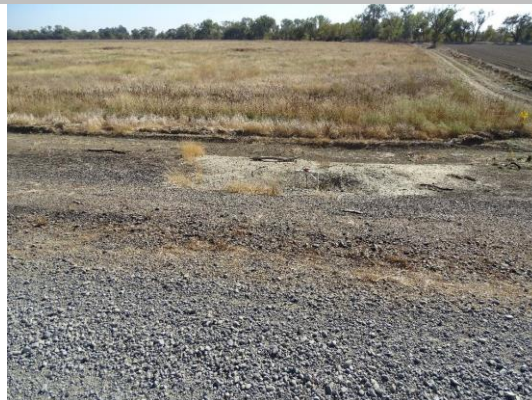
Photo 1 of 3 : UCIP\_FA\_2019\_55584\_82055.jpg

Comment Code					
Inspector Comment					
DS_ID:488 FS_ID:55584 EP_NO: 10261 Repair Type: Non-Urgent Crossing Status: Found UCIP Comments: 11/07/2019 Crossing type should be updated to Irrigation as it serves irrigation purposes. (O.Yakimov - DWR UCIP) FIELD_STRUCT_DESC: 24-inch drainage pipe of unknown material through the levee, 12.5 feet below the crown. Slide gate is located on the waterside (WS) end. Concrete standpipe and headwall are located on the WS. Water well is connected to the standpipe. (24-inch pipe [HLM 0.58] authorized under Automatic Board Order (ABO) issued as Permit No. 10261, 1974 - Tufts) [Additional Reference(s): DWR Levee Log, 1981 and 2005 (HLM 0.58). USACE Sacramento O&M Manual, Unit 119, December 1952, Revised 29 Dec 2016, (Station 31+00). USACE As-Built Drawing No. 50-04-2396, Revision 1, pdf page 19, Sheet 3, December 1947] FS Date: 11/7/2019 9:56:43 AM

View of WS looking from levee crown

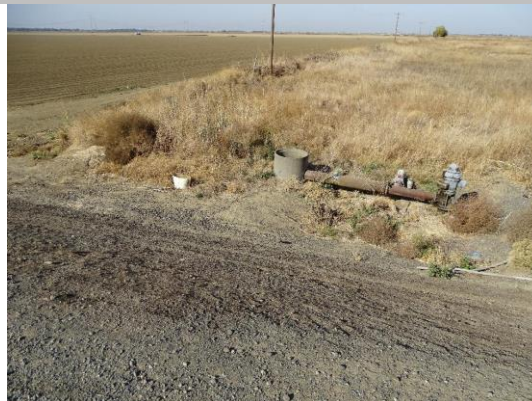
Photo 2 of 3 : UCIP\_FA\_2019\_55584\_82056.jpg

View of LS looking from levee crown

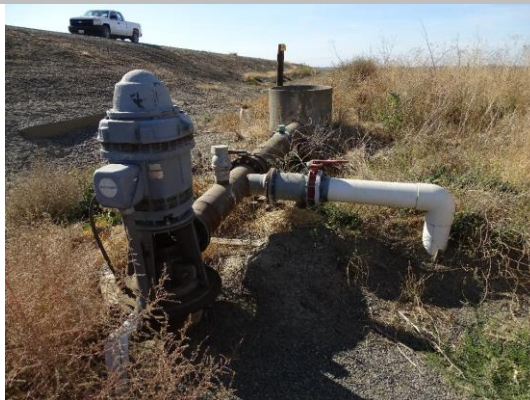
Photo 3 of 3 : UCIP\_FA\_2019\_55584\_82058.jpg

Comment Code						
Inspector Comment						
DS_ID:488 FS_ID:55584 EP_NO: 10261 Repair Type: Non-Urgent Crossing Status: Found UCIP Comments: 11/07/2019 Crossing type should be updated to Irrigation as it serves irrigation purposes. (O.Yakimov - DWR UCIP) FIELD_STRUCT_DESC: 24-inch drainage pipe of unknown material through the levee, 12.5 feet below the crown. Slide gate is located on the waterside (WS) end. Concrete standpipe and headwall are located on the WS. Water well is connected to the standpipe. (24-inch pipe [HLM 0.58] authorized under Automatic Board Order (ABO) issued as Permit No. 10261, 1974 - Tufts) [Additional Reference(s): DWR Levee Log, 1981 and 2005 (HLM 0.58). USACE Sacramento O&M Manual, Unit 119, December 1952, Revised 29 Dec 2016, (Station 31+00). USACE As-Built Drawing No. 50-04-2396, Revision 1, pdf page 19, Sheet 3, December 1947] FS Date: 11/7/2019 9:56:43 AM

Water well connected to standpipe at LS toe. Top of headwall is visible

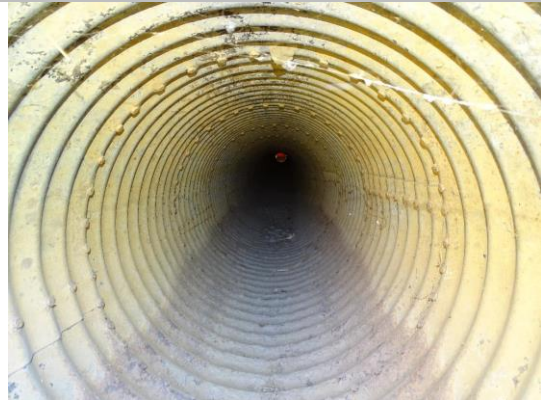
Photo 2 of 3 : UCIP\_FA\_2019\_55455\_81754.jpg

Comment Code					
Inspector Comment					
DS_ID:496					
FS_ID:55455					
EP_NO: 10251					
Repair Type: Non-Urgent					
Crossing Status: Found					
UCIP Comments: 10/22/2019 Installed a new precast concrete box on the waterside. Pipe will be lined in November 2019 according to FMO staff. (O.Yakimov - DWR UCIP)4/10/2019 Major erosion through out pipe. Erosion on WS allows water to enter pipe and flood LS field. Erosion on farmers waterman valve. Field water drains into pipe and floods LS field. (J.McCabe - DWR Sacramento Yard)					
FIELD_STRUCT_DESC: 24-inch corrugated metal drainage pipe through levee, 15 feet below the crown. Two metal cutoff walls were installed through the levee. A T-post and T-handle are located on the landside (LS) toe. The outfall structure and flap gate are located on the west side of bridge, waterside (WS). (24-inch pipe [HLM 3.87] authorized under Automatic Board Order (ABO) issued as Permit No. 10251, 1974 - F.M.C. Corp.) [Additional Reference(s): DWR Levee Log, 1981 and 2005 (HLM 3.87). USACE Sacramento O&M Manual, Unit 119, December 1952, Revised 29 Dec 2016, (Station 1+50 PCT). USACE As-Built Drawing No. 50-04-2396, Revision 4, pdf page 23, Sheet 7, December 1947]

View inside of CMP drainage pipe

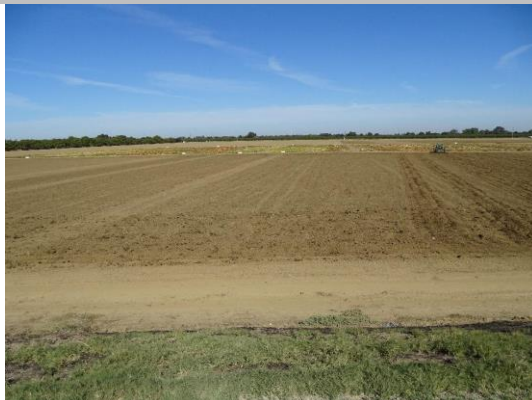
Photo 2 of 3 : UCIP\_FA\_2019\_55456\_81761.jpg

DS\_ID:497  
FS\_ID:55456  
EP\_NO: 10251  
Repair Type: Non-Urgent  
Crossing Status: Found  
UCIP Comments: 10/22/2019 Pipe inlet and headwall are not visible on LS. Slide gate in CMP riser is in closed position, crossing looks abandoned. Construction according to permit 10251-1 hasn't started yet. Field structure description is updated to match original pipe construction. (O.Yakimov - DWR UCIP)  
FIELD\_STRUCT\_DESC: 24-inch pipe through levee, 16 feet below the crown. 36-inch galvanized corrugated metal pipe (CMP) riser located on the waterside (WS) slope. (24-inch pipe [HLM 4.13] authorized under Automatic Board Order (ABO) issued as Permit No. 10251, 1974 - F.M.C. Corp.; assumed original 24-inch pipe was installed in 12/12/1952 per O&M manual) [Additional Reference(s): DWR Levee Log, 1981 and 2005 (HLM 4.13). USACE Sacramento O&M Manual, Unit 119, December 1952, Revised 29 Dec 2016, (Station 17+00 PCT). USACE As-Built Drawing No. 50-04-2396, Revision 4, pdf page 23, Sheet 7, December 1947]

View of LS looking from levee crown

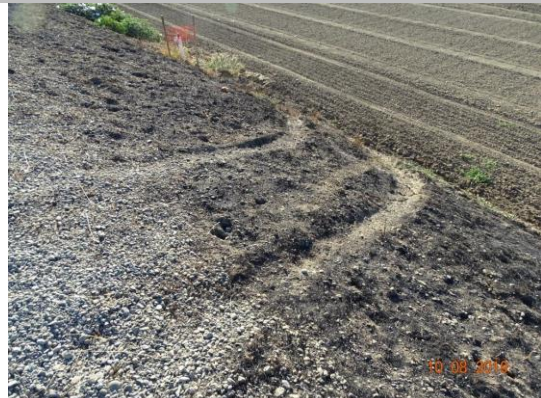
Photo 1 of 1 : FA\_2019\_ST0007\_282\_43\_20191008\_00073.jpg

LM Start	4.57	Rating **	M	Issue No.	43
LM End	4.57	Issue Type +	Ma	Location *	WS
Category	Earthen Levee			GPS Latitude/Longitude	
				Start	End
Item	Slope Stability			38.518175 °	38.518175 °
				-121.709270 °	-121.709270 °
DWR ID	DWR_ST0007_01_f_2019_43				
Comment Code					
S3 : Repair the levee slope damaged by vehicle traffic and prevent access where possible.					
Inspector Comment					
Vehicle tracks depressed into slope.

View of vehicle tracks on the waterside slope (Fall 2019).

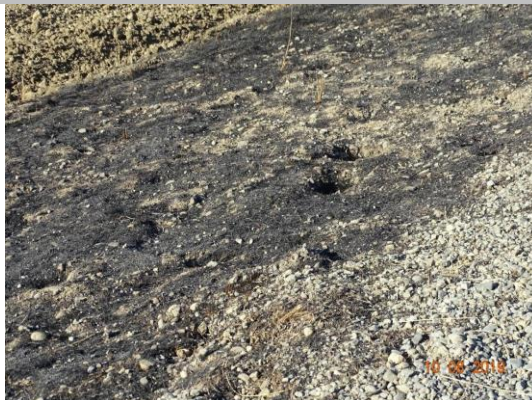
Photo 1 of 1 : FA\_2019\_ST0007\_282\_44\_20191008\_00074.jpg

View of animal holes on the waterside slope (Fall 2019).

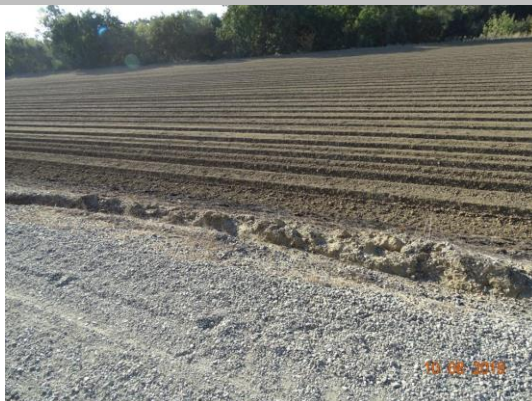
Photo 1 of 1 : FA\_2019\_ST0007\_282\_45\_20191008\_00077.jpg

LM Start	5.24	Rating **	M	Issue No.	45
LM End	5.24	Issue Type +	Ma	Location *	WS
Category	Earthen Levee			GPS Latitude/Longitude	
				Start	End
Item	Slope Stability			38.518142°	38.518142°
				-121.721778°	-121.721778°
DWR ID	DWR_ST0007_01_f_2019_45				
Comment Code					
S3 : Repair the levee slope damaged by vehicle traffic and prevent access where possible.					
Inspector Comment					
Vehicle depression on the waterside shoulder.

View of vehicle track depression on waterside shoulder (Fall 2019).

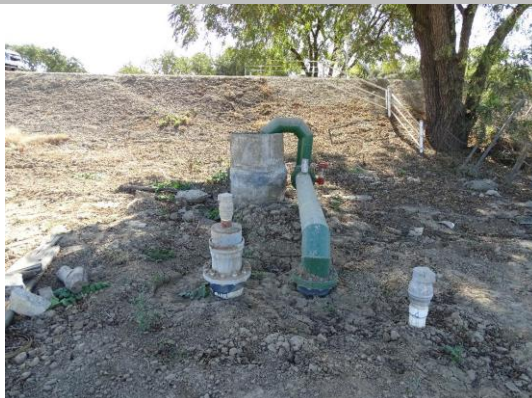
Photo 1 of 3 : UCIP\_FA\_2019\_55460\_81779.jpg

Comment Code					
Inspector Comment					
DS_ID:501 FS_ID:55460 EP_NO: 10256 Repair Type: Non-Urgent Crossing Status: Found UCIP Comments: 10/22/2019 Crossing has been modified to supply water from LS to WS. Should not be considered a storm drainage pipe. (O.Yakimov - DWR UCIP) FIELD_STRUCT_DESC: 24-inch corrugated metal drainage pipe through the levee, 12.5 feet below the crown. Slide gate on the waterside (WS) end in 36-inch standpipe. Concrete standpipe at LS toe with fill-in pipe. (24-inch pipe [HLM 5.40] authorized under Automatic Board Order (ABO) issued as Permit No. 10256, 1974 - Albert H. Lederer). [Additional Reference(s): DWR Levee Log, 2005 (HLM 5.40). USACE Sacramento O&M Manual, Unit 119, December 1952, Revised 29 Dec 2016, (Station 84+40 PCT). USACE As-Built Drawing No. 50-04-2396, Revision 4, pdf page 24, Sheet 8, December 1947]. FS Date: 10/22/2019 3:28:15 PM

View of LS slope with concrete standpipe at levee toe

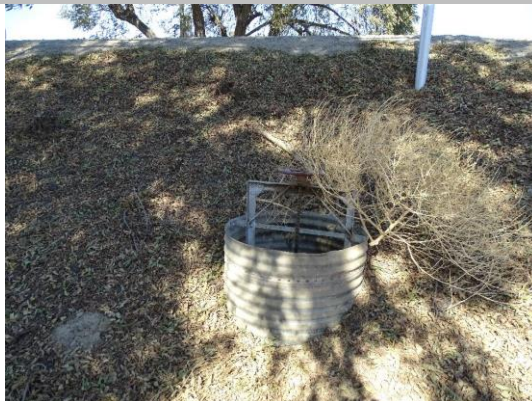
Photo 2 of 3 : UCIP\_FA\_2019\_55460\_81780.jpg

36-inch CMP standpipe with slide gate at WS levee toe

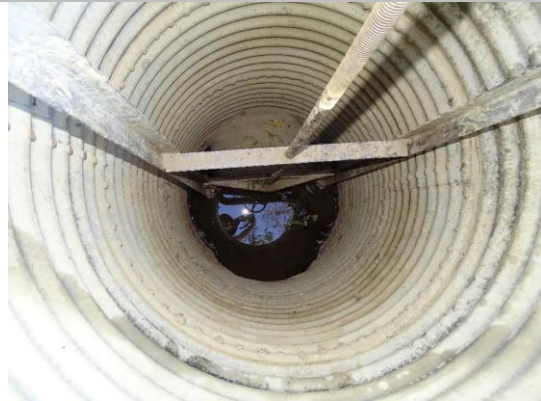
Photo 3 of 3 : UCIP\_FA\_2019\_55460\_81781.jpg

View inside of CMP standpipe on WS

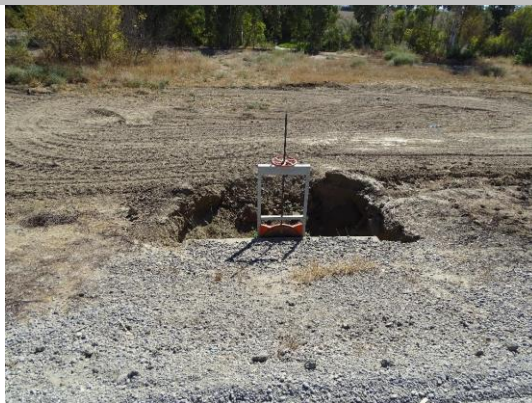
Photo 2 of 3 : UCIP\_FA\_2019\_55647\_82274.jpg

Comment Code						
Inspector Comment						
DS_ID:505 FS_ID:55647 EP_NO: 10253 Repair Type: Non-Urgent Crossing Status: Found UCIP Comments: 10/22/2019 Levee toe erosion on both sides of headwall on WS. (O.Yakimov - DWR UCIP) FIELD_STRUCT_DESC: 24-inch CIPP-lined corrugated metal drainage pipe through the levee, 10.4 feet below the crown. Slide gate on the waterside (WS), and concrete headwalls on both the WS and the landside (LS). (24-inch pipe [HLM 6.57] authorized under Automatic Board Order (ABO) issued as Permit No. 10253, 1974 - Lester J. Hamel). [Additional Reference(s): DWR Levee Log, 2005 (HLM 6.57. USACE Sacramento O&M Manual, Unit 119, December 1952, Revised 29 Dec 2016, (Station 145+50 PCT). USACE As-Built Drawing No. 50-04-2396, Revision 4, pdf page 24, Sheet 8, December 1947]. FS Date: 10/22/2019 11:07:35 AM

View of WS looking from levee crown

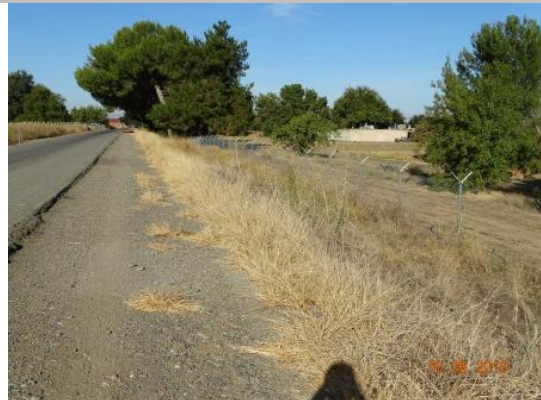
Photo 1 of 1 : FA\_2019\_ST0007\_282\_49\_20191008\_00080.jpg

View looking upstream at vegetation on the landside slope (Fall 2019).

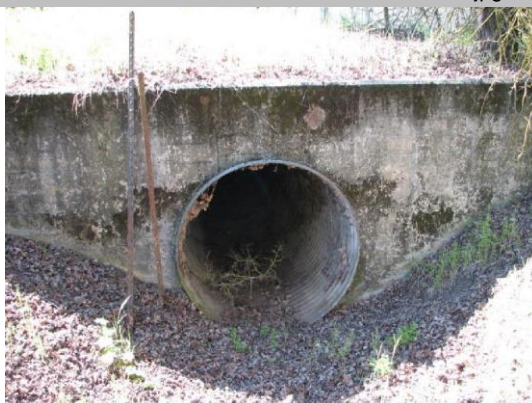
Photo 3 of 3 : UCIP\_FA\_2019\_55684\_60299.jpg

LS headwall and pipe before steel plate was installed over pipe to abandon it.

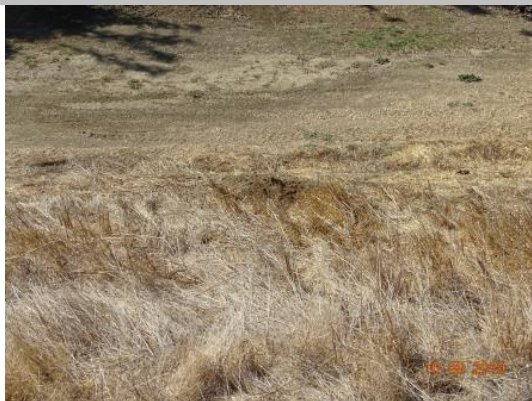
Photo 1 of 2 : FA\_2019\_ST0007\_283\_32\_20191008\_00066.jpg

View looking downslope at animal hole with fresh dirt (Fall 2019).

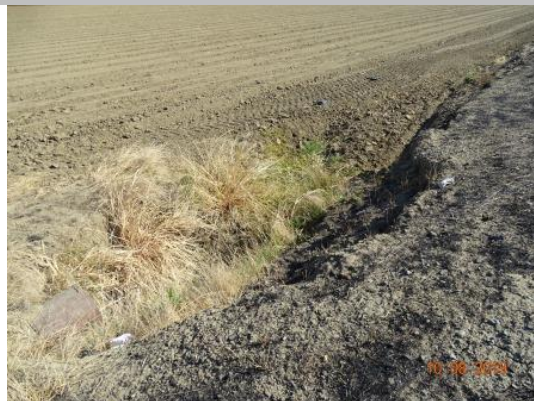
Photo 1 of 2 : FA\_2019\_ST0007\_283\_33\_20191008\_00065.jpg

View of erosion on the levee slope (Fall 2019).

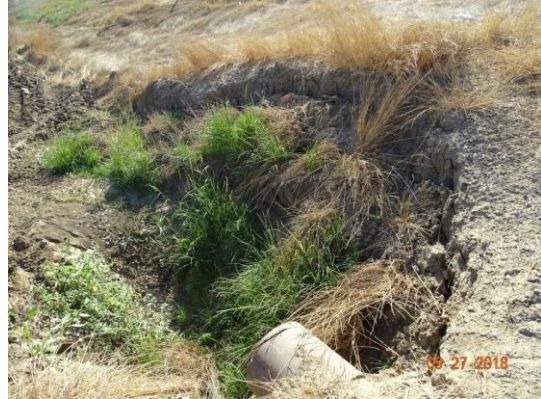
Photo 2 of 2 : FA\_2019\_ST0007\_283\_33\_20190826\_00013.jpg

View of erosion on the levee slope appears to be due to water from the pipe and trench (September 2018).
